Dhamma Talaka Peace Pagoda

Project	Dhamma Talaka Peace Pagoda Condition Survey	Scale	NTS	Job No.	2166
Drawing	Elevation showing Building Elements and Cosmological Meaning	Date	March 2022	Dwg. No.	01
		Drawn	ds	Rev.	-

Report on 29th June 2022 by Oliver Architecture Ltd.

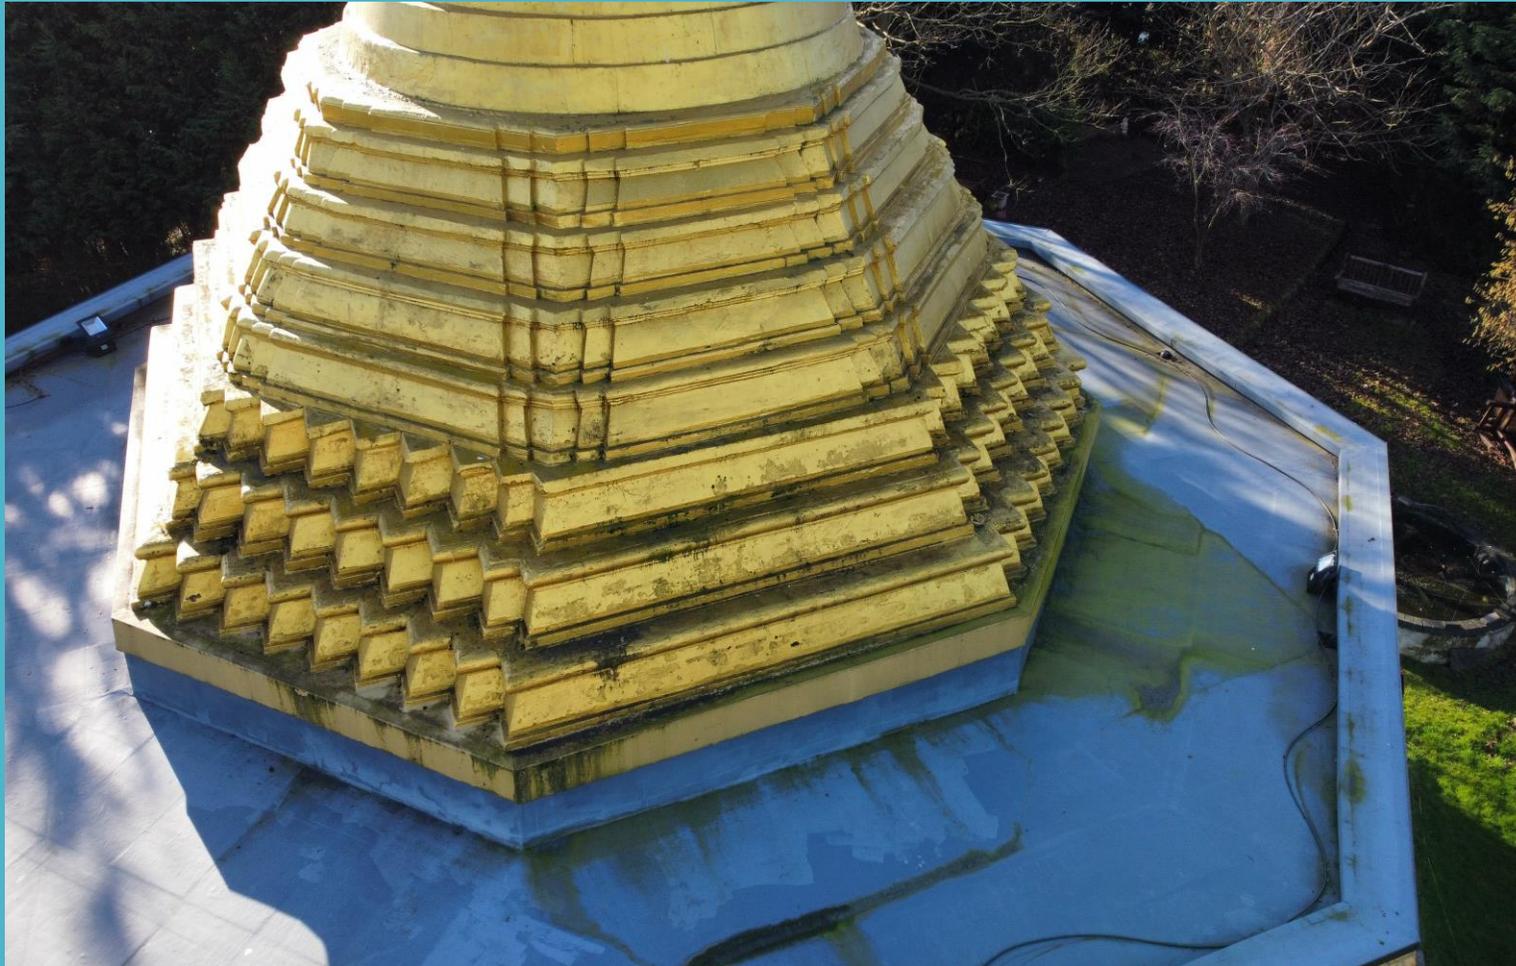
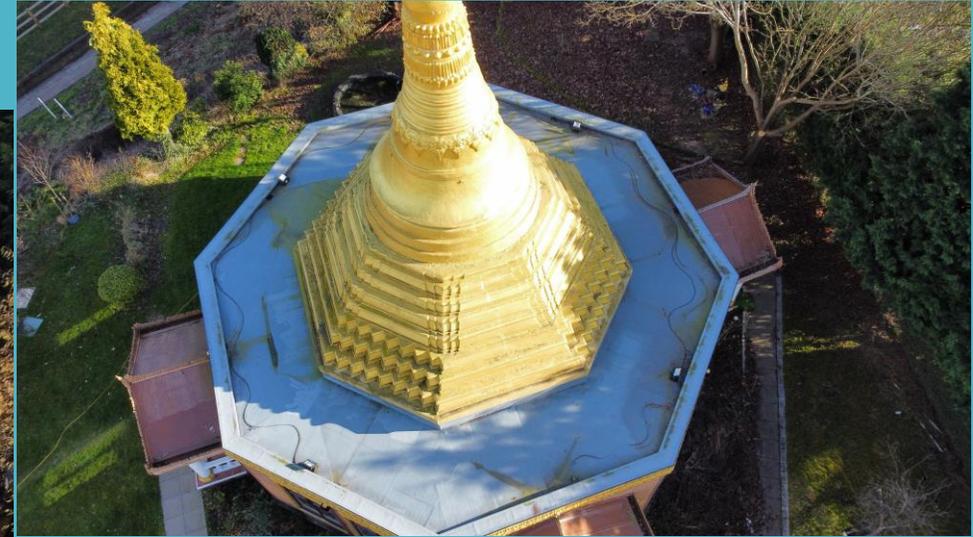
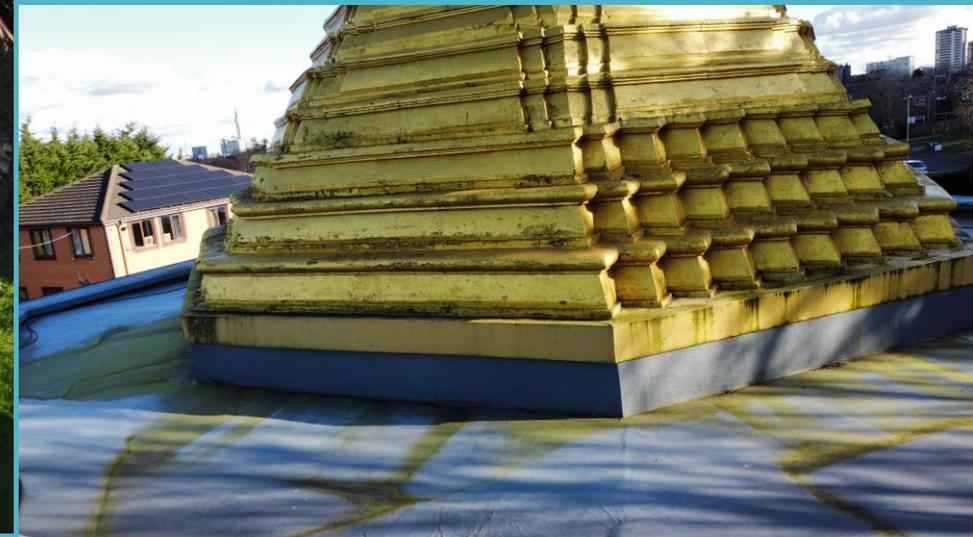
Gold Paint run off

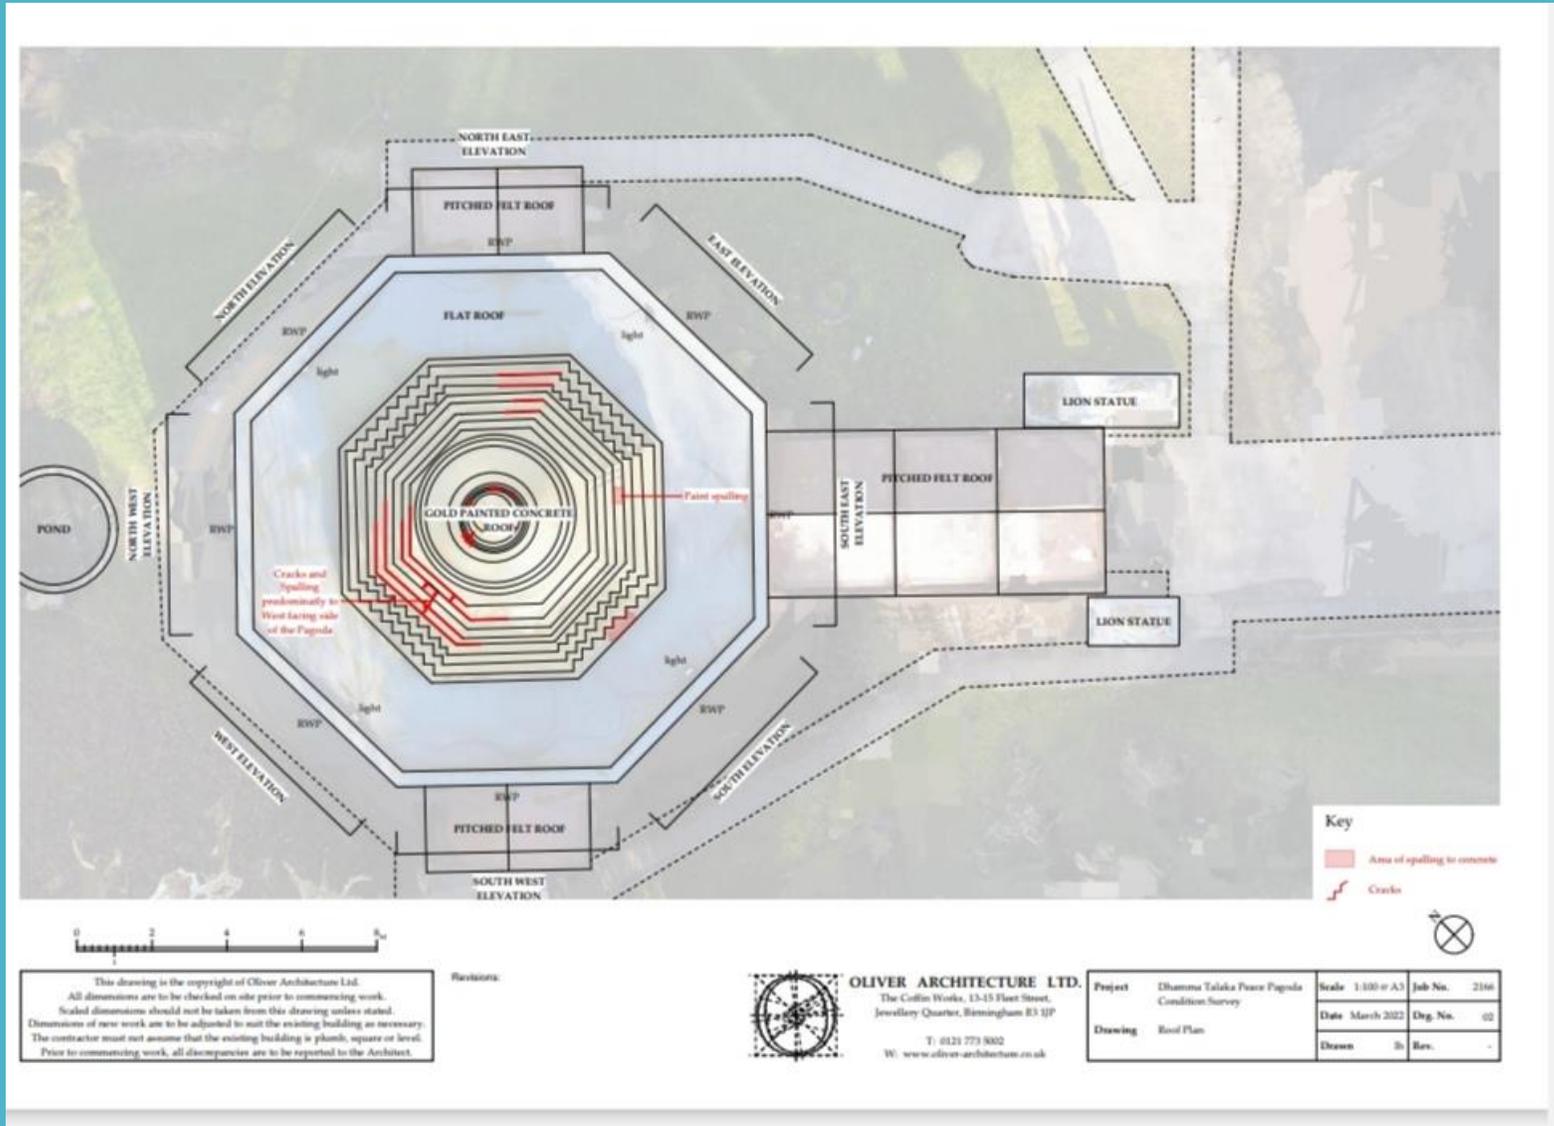
Project	Dhamma Talaka Peace Pagoda	Scale	1:100 @ A3	Job No.	2166		
	Condition Survey		Date		March 2022	Drp. No.	02
	Drawing		Roof Plan		Drawn	By	Rev.

- The flat roof is in good condition although the flashing detail between it and the pagoda - the pointing is failing and there is minimal overlap so some water can be getting in at that point (*to the circumference of the dome*)

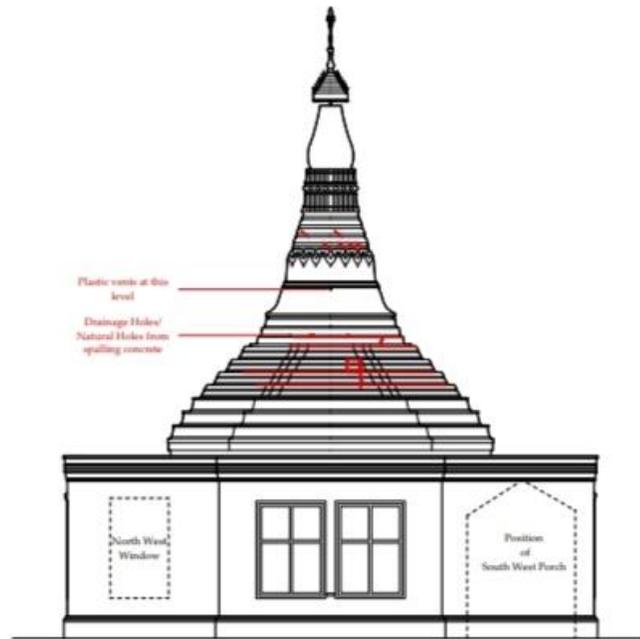
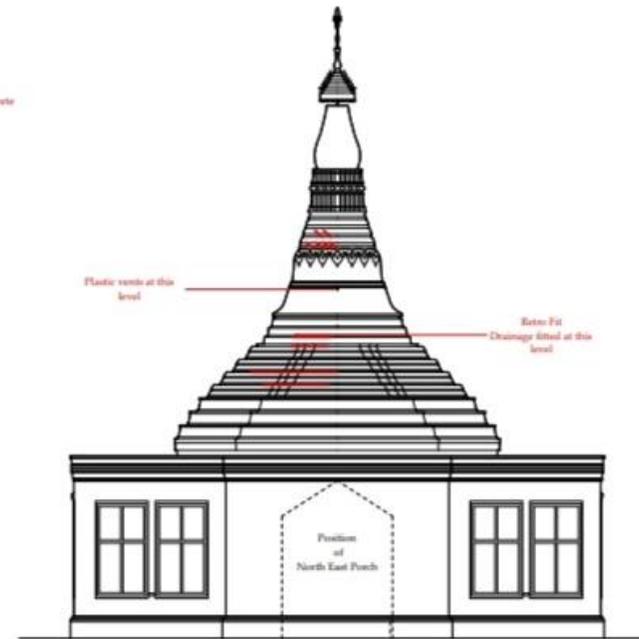
WEST ELEVATION

Project	Dhamma Talaka Peace Pagoda	Scale	NTS	Job No.	2106
	Condition Survey	Date	March 2022	Dwg. No.	04
Drawing	North West and East Elevations	Drawn	ryj	Rev.	-
	Defects

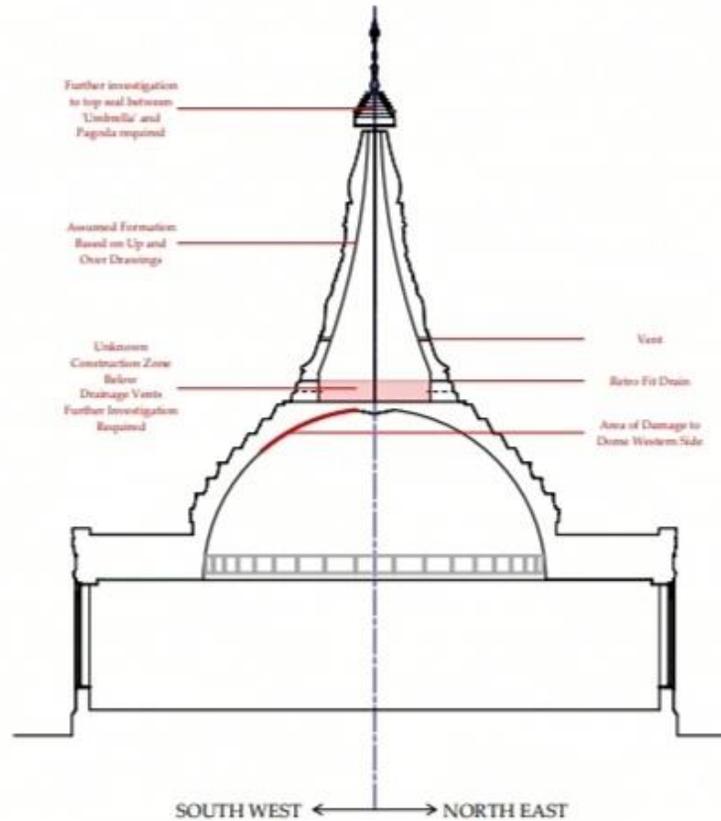
Project	Dhamma Talaka Peace Pagoda Condition Survey	Scale	NTS	Job No.	2106
	Drawing	Section West - East Defects	Date	March 2022	Drawn
			Drawn	myf	Rev.
